IPSAC project: Pile Survey for Swanage Pier (2025)

Overview

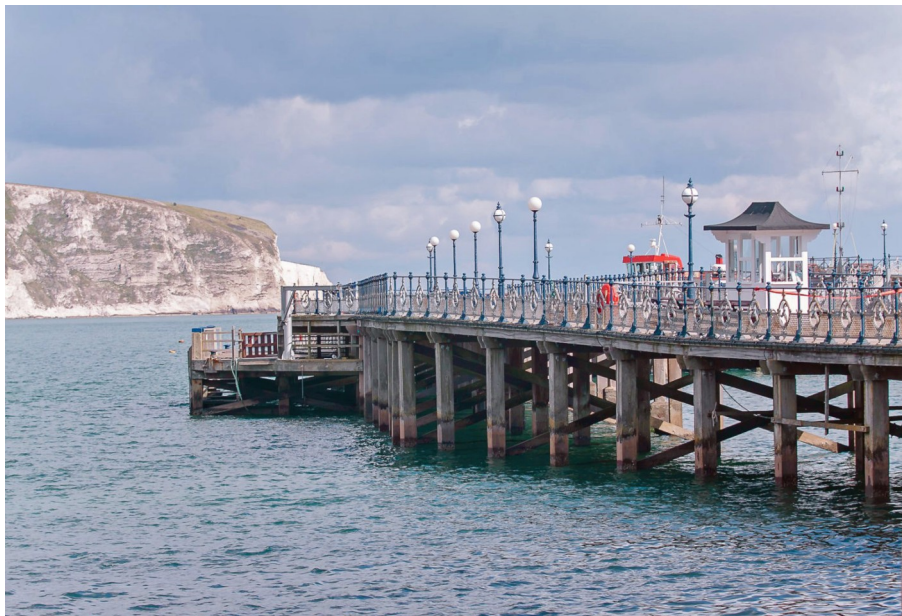
A pier leg is known as a pile. There are 45 bents (rows of piles) within the pier structure. There are normally 3 piles across a bent. Additional piles are in place in the rows underneath the intermediate and main boat decks. Furthermore, piles are doubled up on the outside edge of the boat decks; this is so the outer pile takes any thrust from mooring ferries while the inner pile supports the pier structure. The piles are braced horizontally by the use of cross and diagonal bracings and stringers.

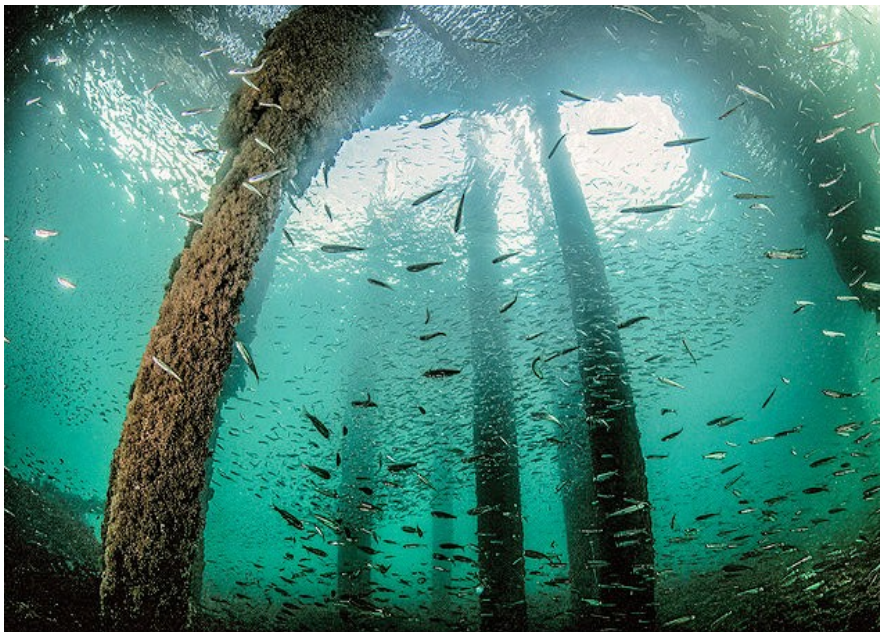
Divers from IPSAC (the local Isle of Purbeck Sub Aqua Club), have been inspecting the piles from the seabed to the cross bracing at mid-tide level. This work was carried out between June and August 2025 and 200 piles were inspected.

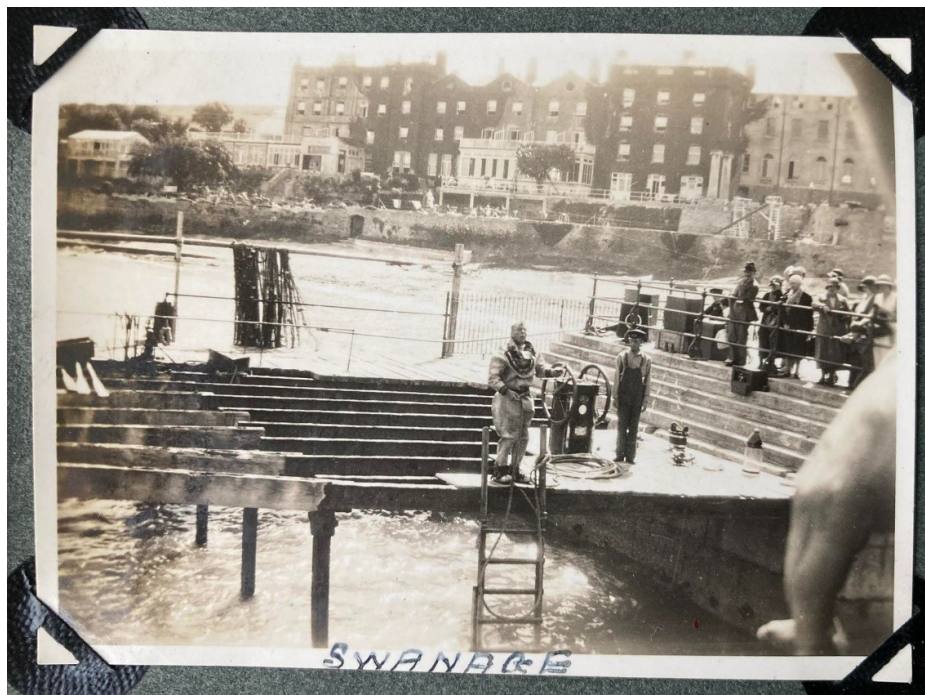
The image, discovered in a family album and shared on a Swanage Facebook page by the photographer's grandson, was taken from the new pier looking toward the old pier. It is most likely that the diver was George Stevenson and his assistant was the Piermaster, Edward Brunsdn; George subsequently became Piermaster.

The diver appears to be installing cast iron piles to support a new platform attached to the old pier – possibly part of Du Plat Taylor's work in the late 1920s to install the concrete sleeves to reinforce piles damaged by gribble at mid-tide level.

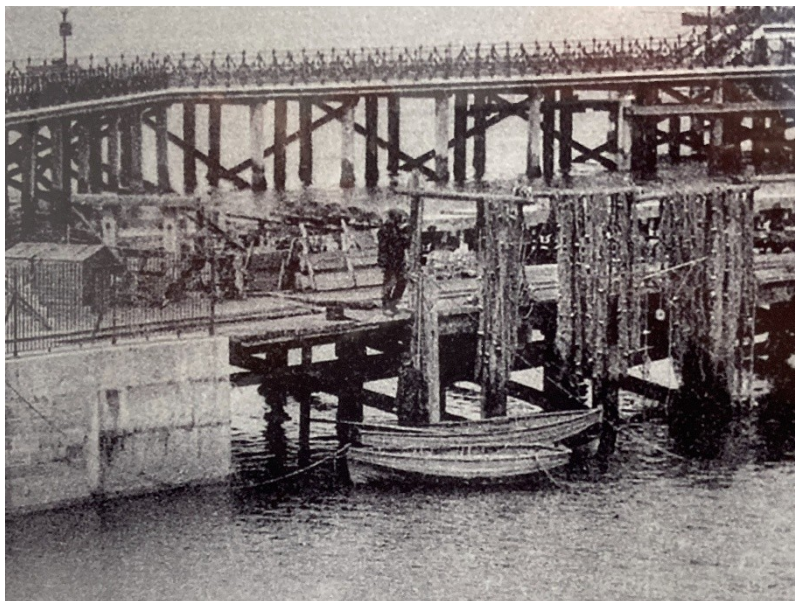
*Photo taken from the Grosvenor Hotel:
Shows the platform in use as storage for local fishermen.*
